EXISTING CONDITIONS
EASTON PARK SECTION 2B PRELIMINARY PLAN
AUSTIN, TRAVIS COUNTY, TEXAS

Carma Easton:
City of Austin
Environmental
Assessment

Re: City of Austin Environmental Assessment and Threatened and Endangered Species Habitat Assessment

Pilot Knob PUD
Intersection of Colton Bluff Springs Road and McKinney Falls Parkway
Austin, Travis County, Texas

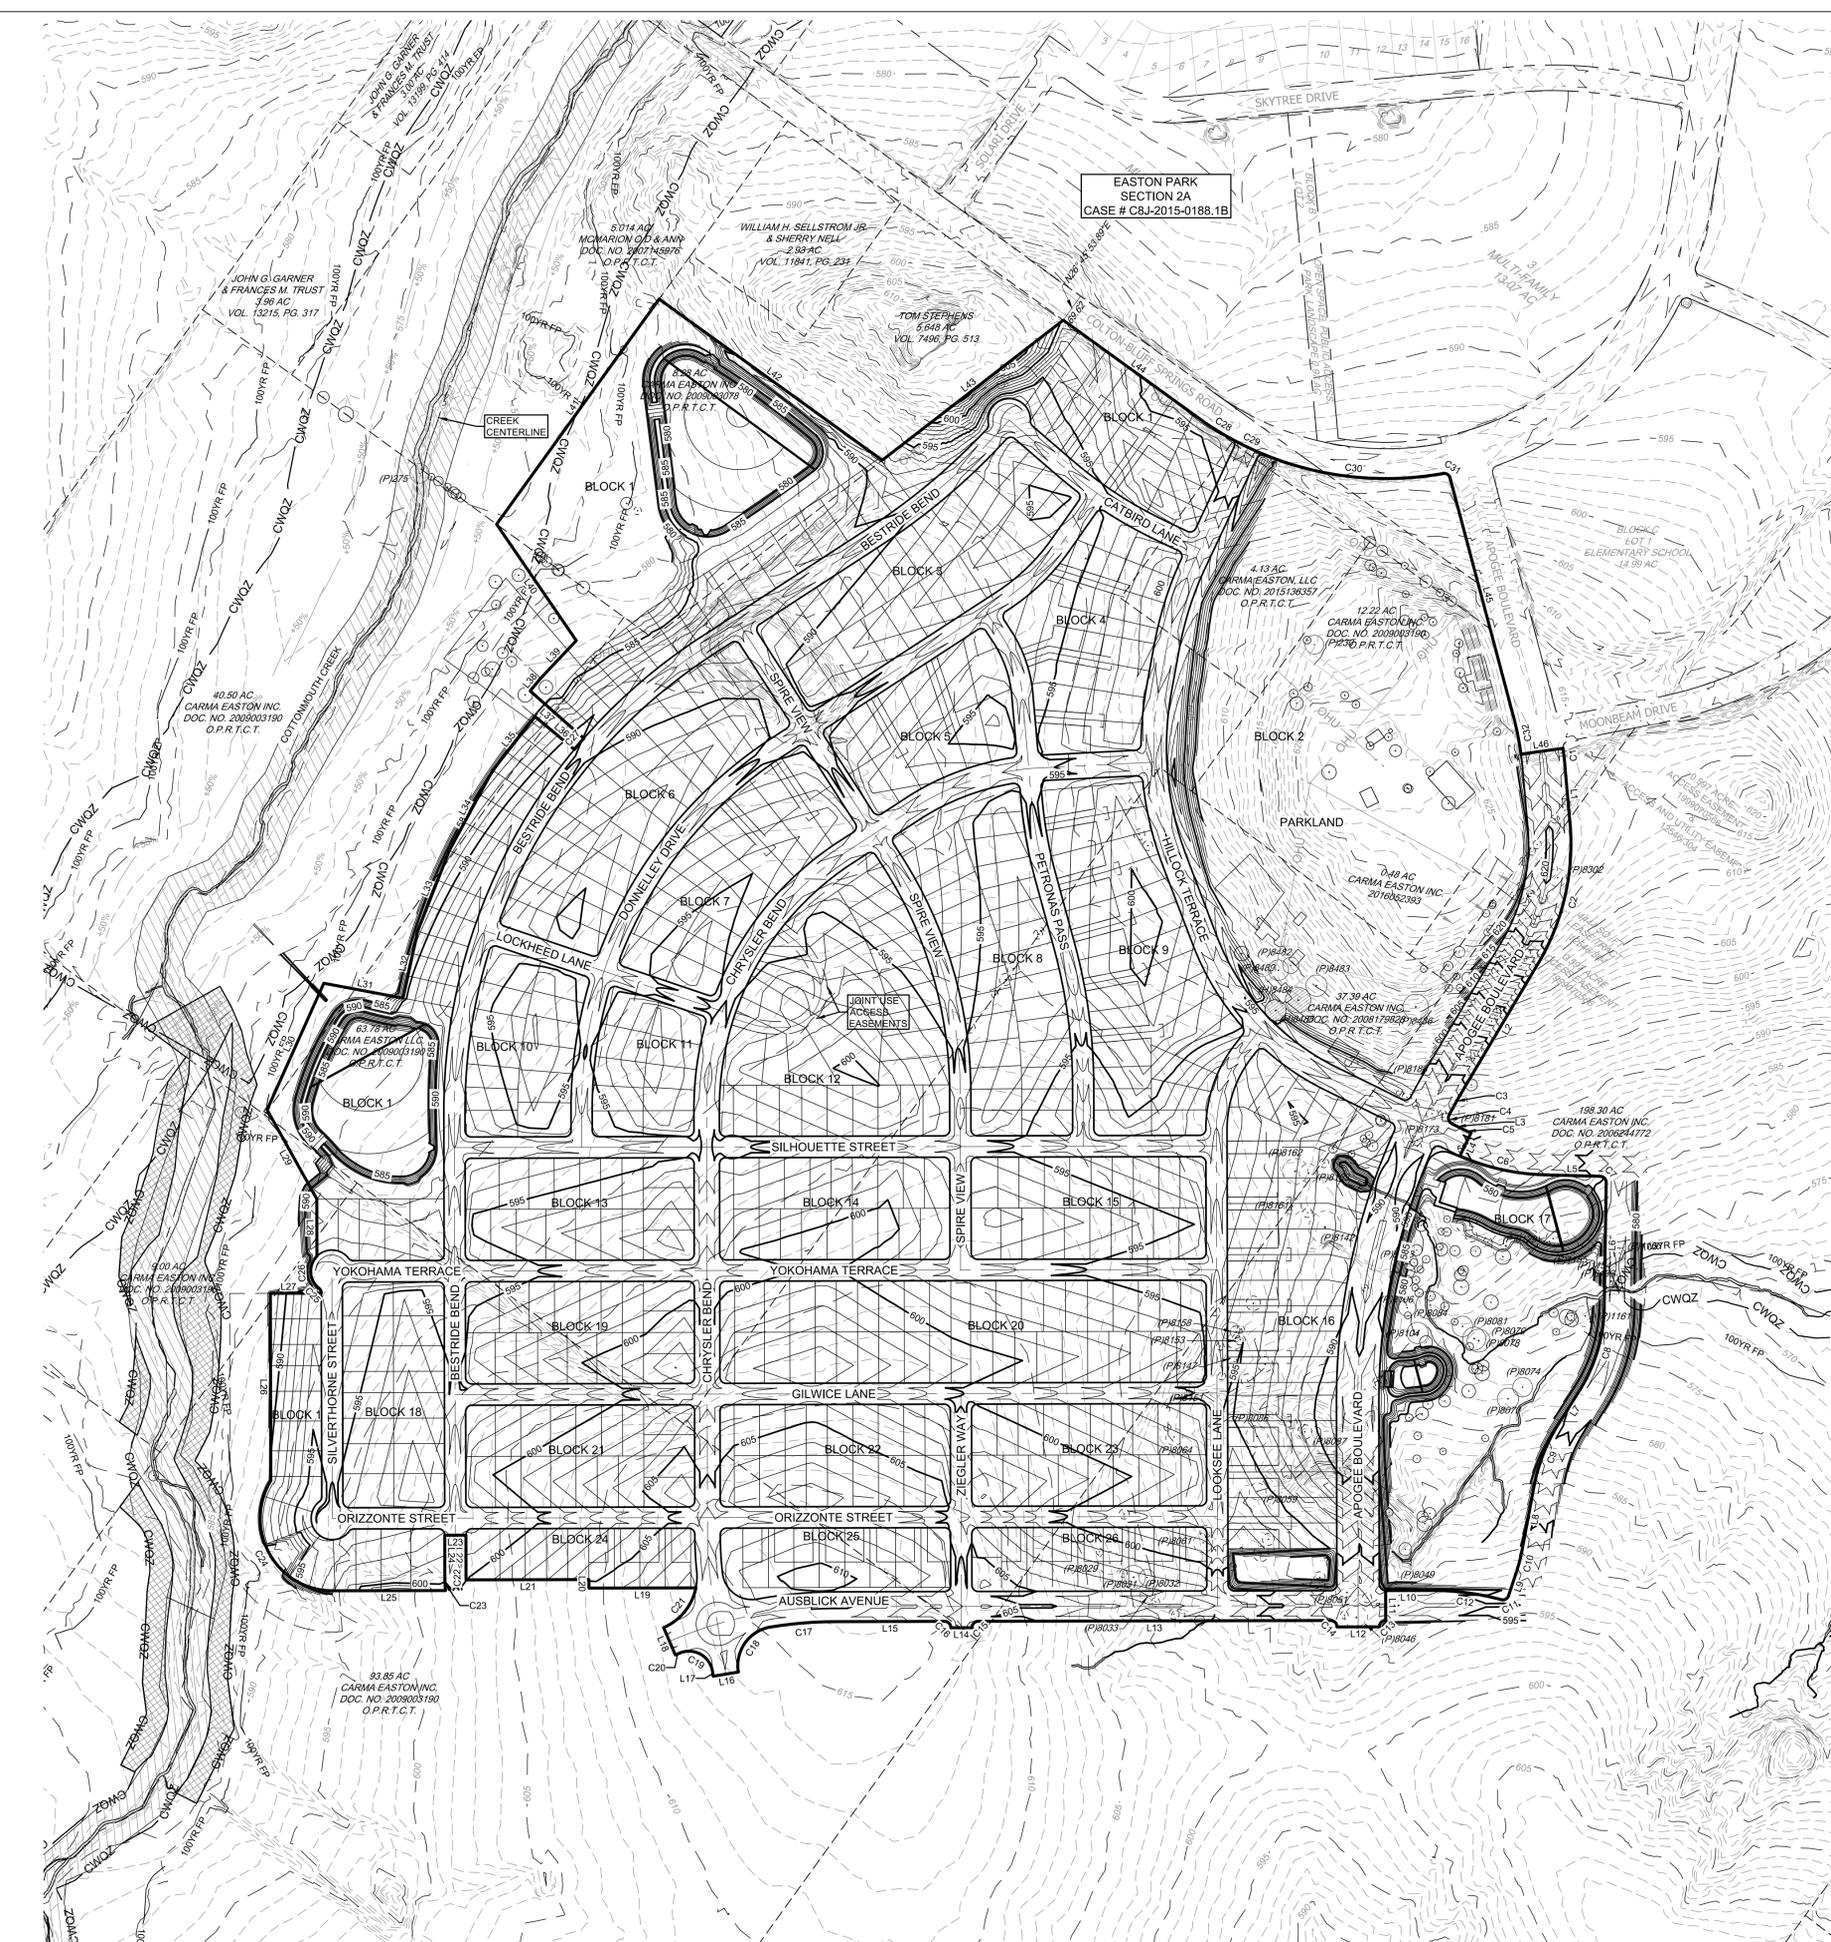
E.8
TOPOGRAPHIC MAP

TOPOGRAPHIC EXHIBIT

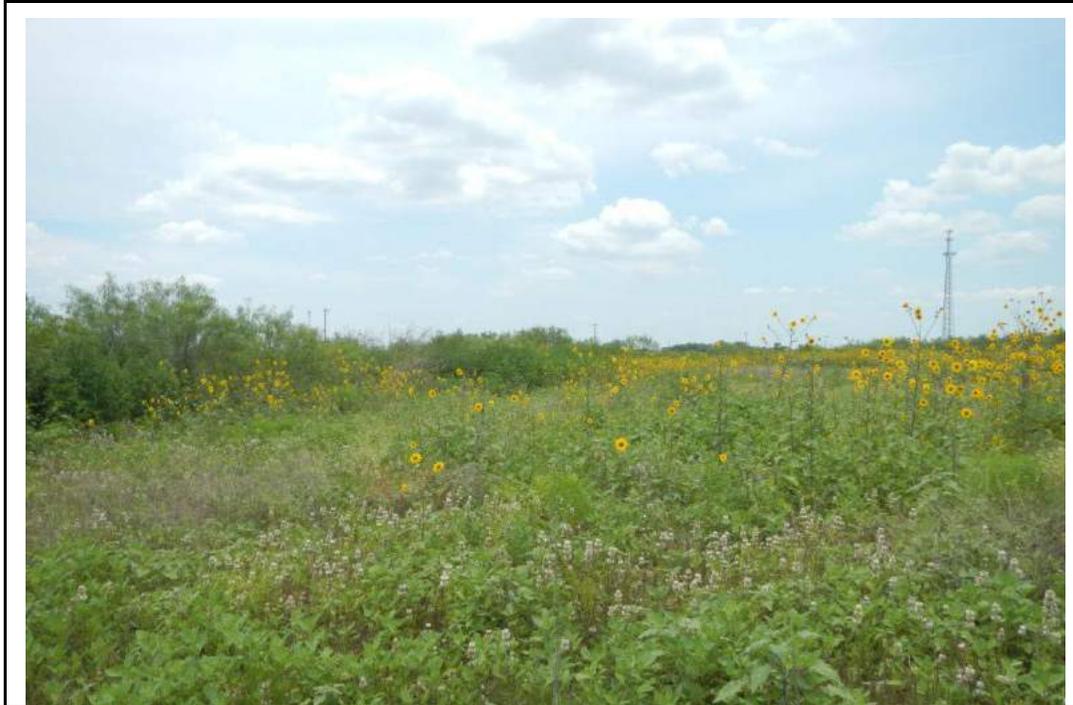
Photograph 1. Typical view of native rangeland and abandoned cropland with wooded corridors along fencerows.

The site predominately consists of cropland primarily used for hay production, native rangeland, and abandoned cropland with wooded corridors along fence rows (**Appendix B, Photograph 1**). Tributaries of Cottonmouth Creek, North Fork Dry Creek, and Dry Creek (locally named "South Fork Dry Creek") traverse throughout portions of the properties.

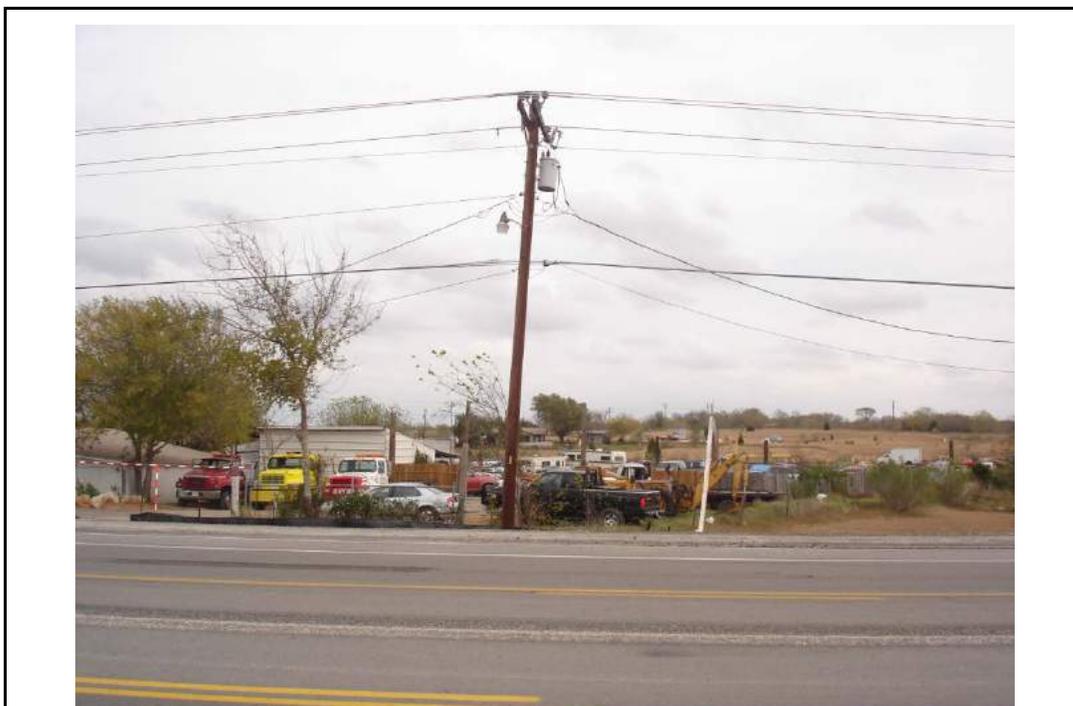
Photograph 2. View of commercial land to the southeast of the site.

development site appear to consist of agricultural land with associated farmsteads and commercial properties to the northeast; residential development, agricultural land with associated farmsteads, and commercial properties to the southeast (**Appendix B, Photograph 2**); residential development and agricultural land with associated farmsteads to the southwest; and commercial properties and residential subdivisions to the northwest.

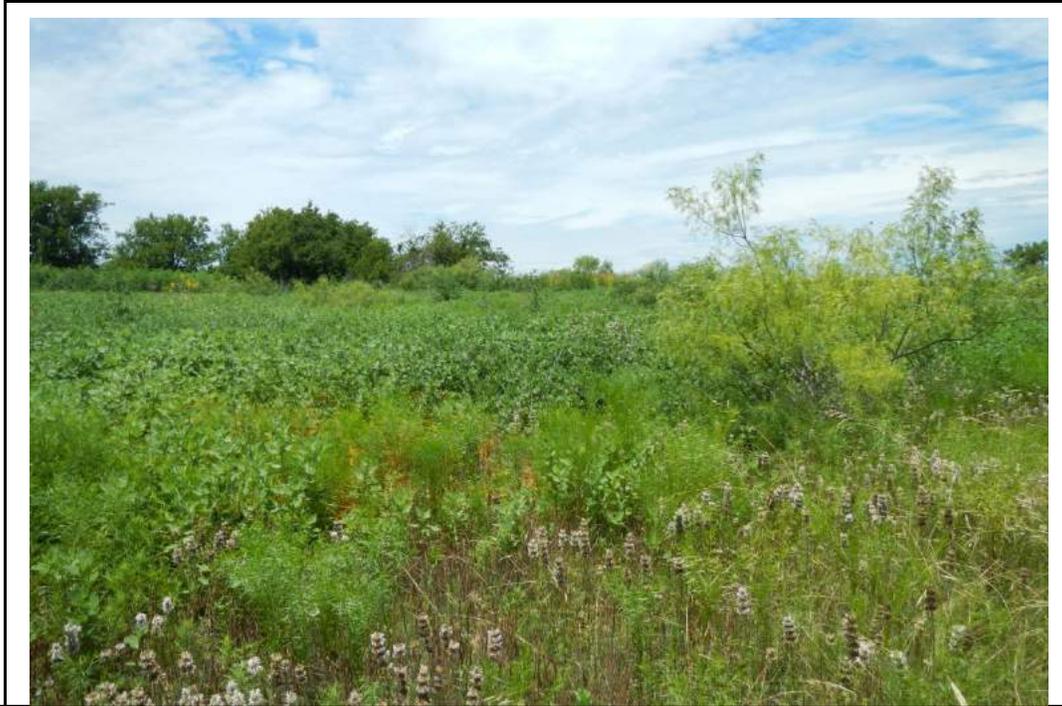
Photograph 3. Typical view of upland rangeland vegetation. View to the east.

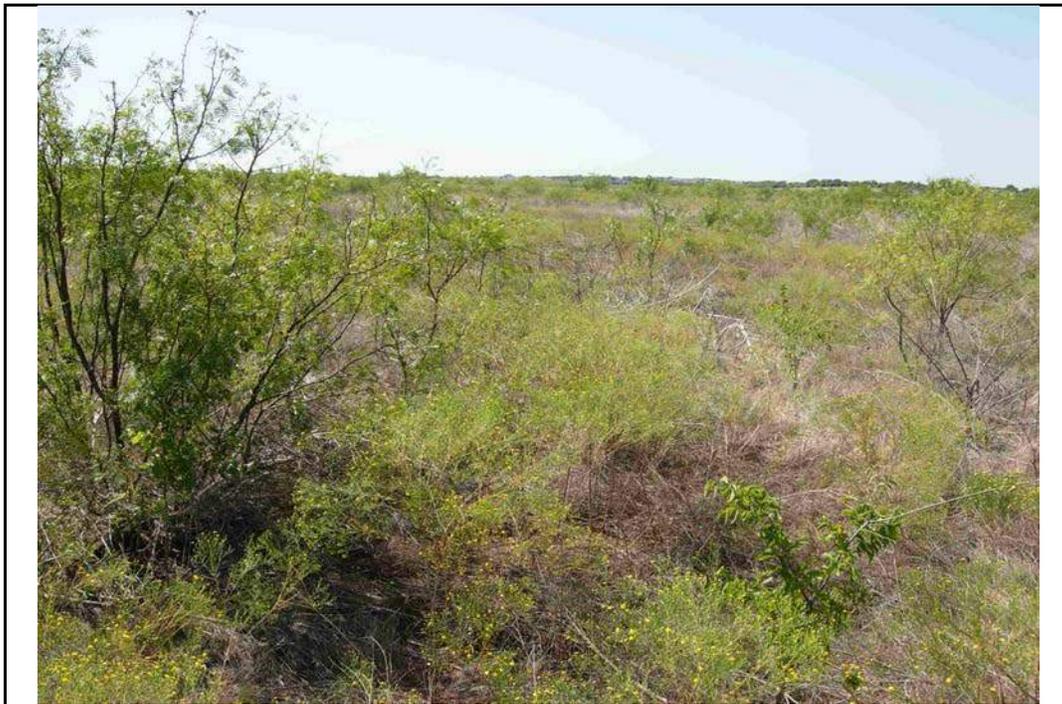
Photograph 4. Typical view of upland woody vegetation. View to the south.

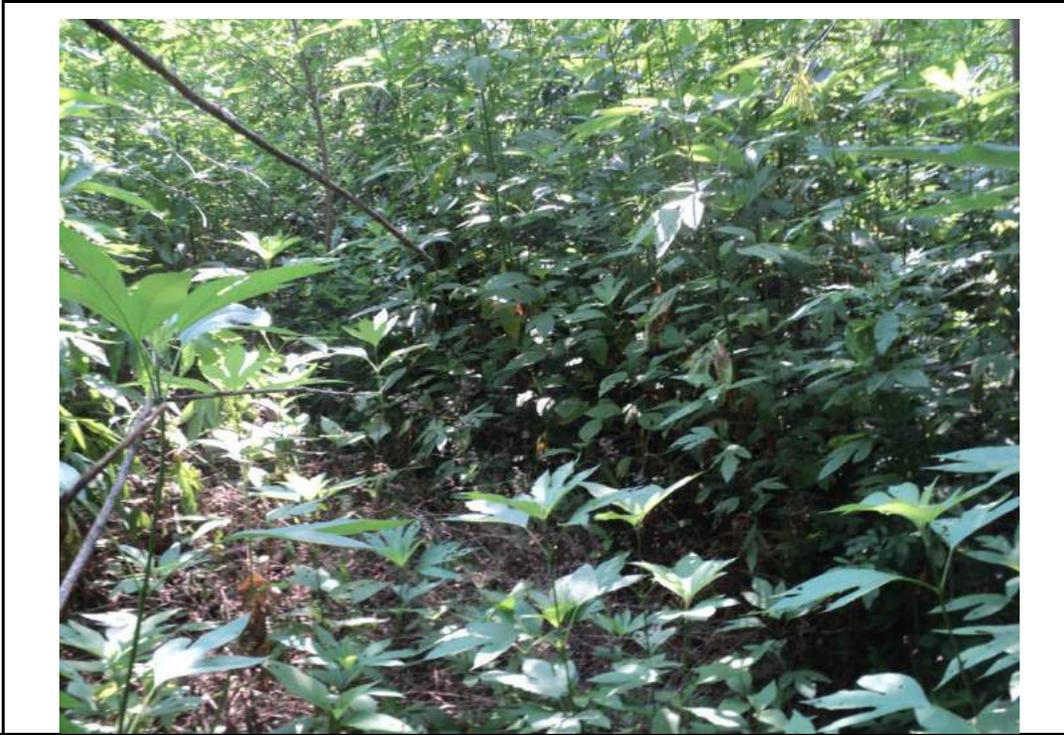
Photograph 5. Typical view of bottomland vegetation within North Fork Dry Creek. View to the north.

The majority of the project site consisted of upland range vegetation including Japanese brome (*Bromus japonicus*), King Ranch bluestem (*Bothriochloa ischaemum var. songarica*), silver bluestem, horsemint (*Monarda citriodora*), giant ragweed (*Ambrosia trifida*), sumpweed (*Iva annua*), goldenrod (*Solidago virgaurea*), Texas wintergrass, and Johnson grass (*Sorghum halepense*) (**Appendix B, Photograph 3**). Upland woody vegetation observed consisted of hackberry (*Celtis laevigata*), Ashe's juniper (*Juniperus ashei*), mesquite, mustang grape (*Vitis mustangensis*), eastern red cedar (*Juniperus virginiana*), and gum bumelia (*Sideroxylon lanuginosum*) (**Appendix B, Photograph 4**). Bottomland vegetation observed consisted of cottonwood (*Populus deltoids*), chinaberry (*Melia azedarach*), black willow (*Salix nigra*), hackberry, boxelder (*Acer negundo*), and giant ragweed (**Appendix B, Photograph 5**).

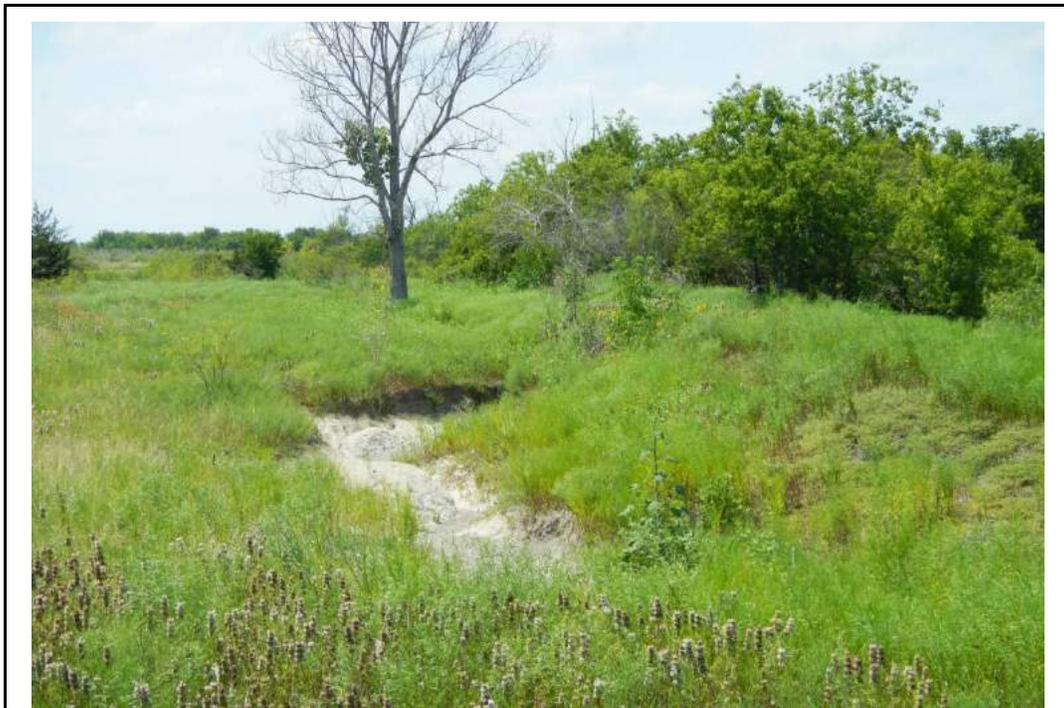
Photograph 6. Typical view of North Fork Dry Creek. View to the west.

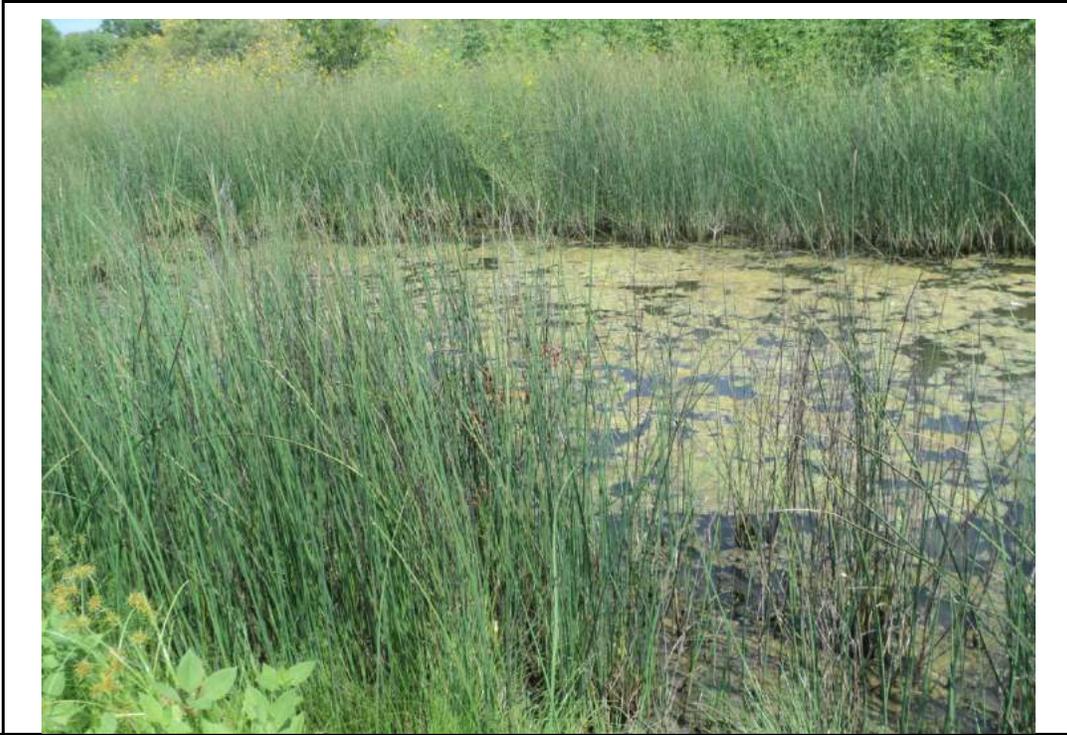
Photograph 7. Typical view of wetland 2 vegetation. View to the north.

Wetlands were also evaluated within the site. Wetlands are those "areas that are inundated or saturated by surface or ground water at a frequency and duration sufficient to support, and that under normal circumstances do support, a prevalence of vegetation typically adapted for life in saturated soil conditions" as defined by the U.S. Army Corps of Engineers (USACE) and U.S. Environmental Protection Agency. Wetlands were delineated within the site, as described by the criteria in the 1987 USACE Wetland Delineation Manual (USACE 1987). Five wetlands were identified on site. Vegetation within these wetlands consisted of black willow, yellow nutsedge (*Cyperus esculentus*), bald spikerush (*Eleocharis erythropoda*), bulrush (*Scirpus spp.*), cattail (*Typha spp.*), curly dock (*Rumex crispus*), and sumpweed (**Appendix B, Photograph 7 and 8**).

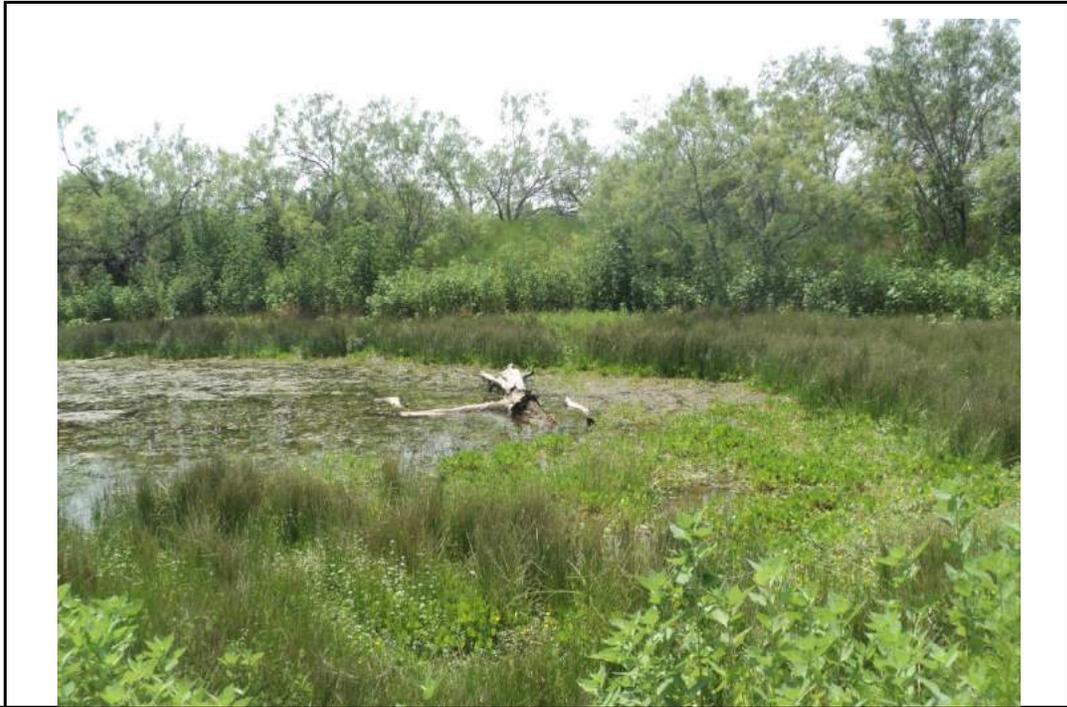
Photograph 8. Typical view of wetland fringe around pond 27. View to the west.

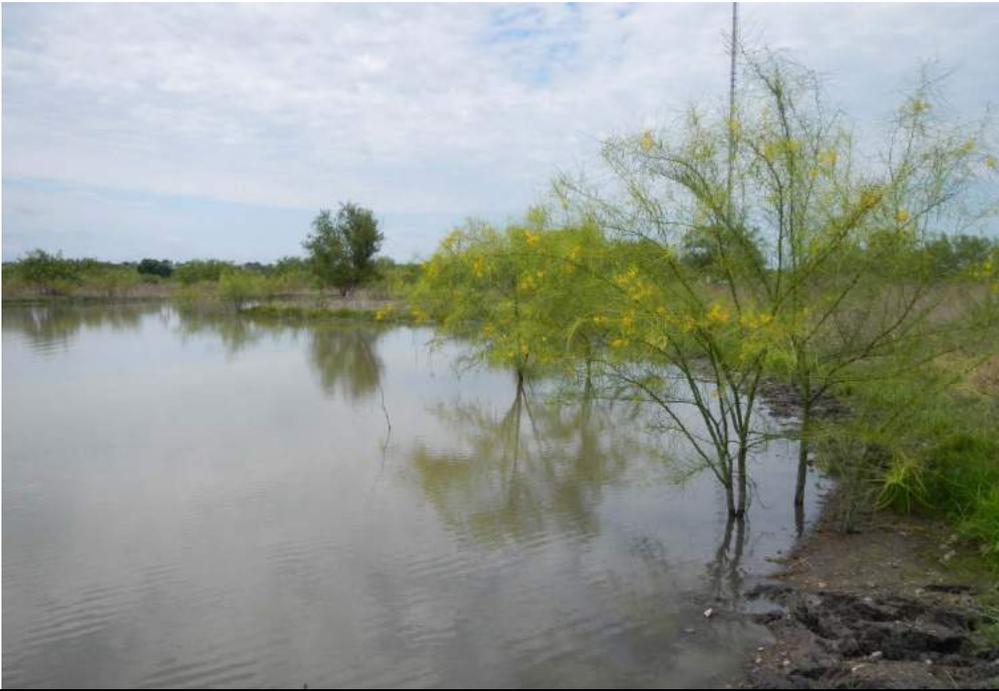
Photograph 9. Typical view of an upland pond. View to the northeast.

There were also a total of twenty-six ponds (seventeen upland and nine on-channel) located on the project site (**Appendix B, Photograph 9**). The majority of the ponds were barren in vegetation along the banks; some did consist of black willow, hackberry, and Chinese tallow tree (*Triadica sebifera*) (**Appendix B, Photograph**

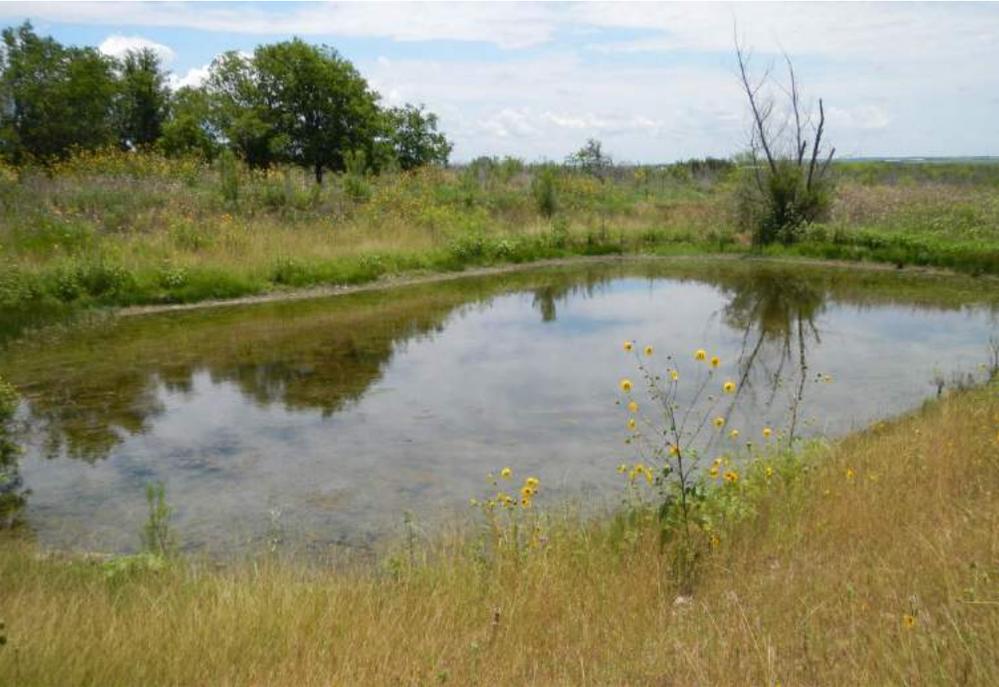
Photograph 10. Typical view of vegetation along banks of pond. View to the north.

10). Although upland ponds are generally not considered jurisdictional by the USACE, the COA considers them important features due to their relationship with associated wetland fringe along their banks (ten total ponds with associated wetland fringe).

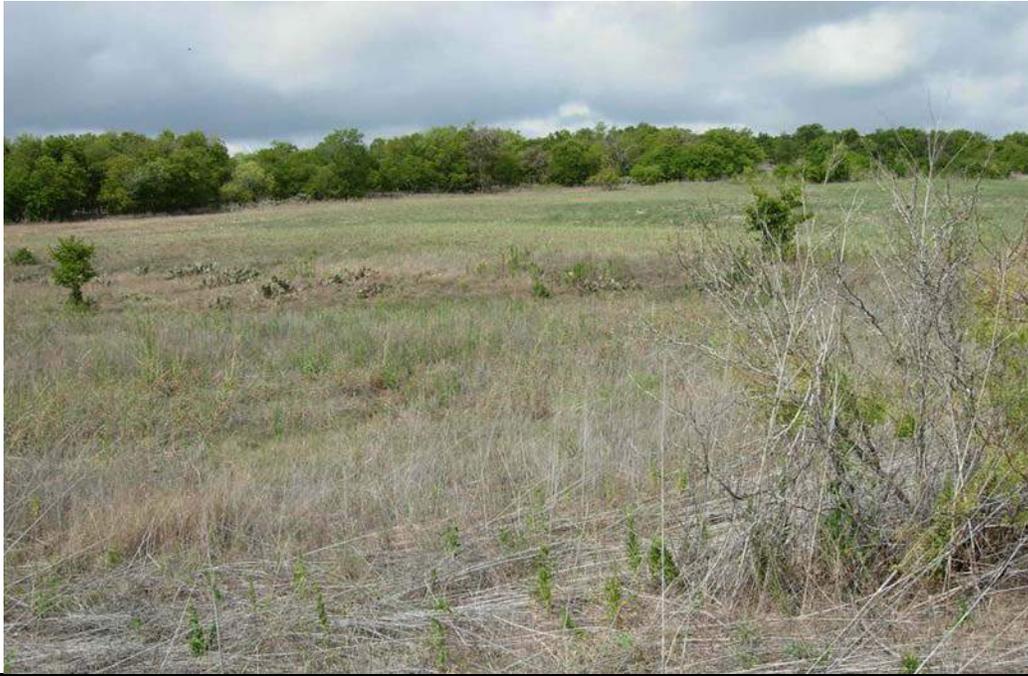
Photograph 11. Typical view of dry upland pond. View to the west.

There was an upland pond, located north of Colton Bluff Springs Road and west of Cottonmouth creek, that was determined not a CEF (**Appendix B, Photograph 11**). The upland vegetation growing in the pond borrow area and spoil embankment area was similar to vegetation already described in this report, therefore, it is apparent that the pond does not hold water and does not exhibit any wetland features. The nature of the chalky sub soil layers is not conducive to holding water for extended periods of time. **Table 2** provides a summary of all waters within the site.

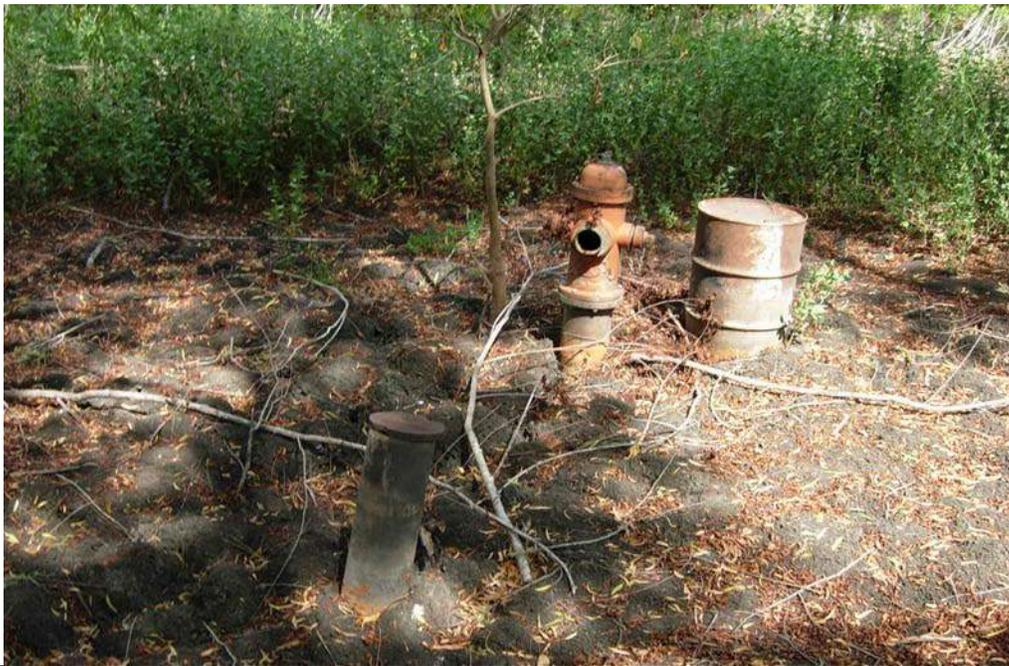
Photograph 12. Typical view of abandoned fire hydrant and piping. View to the north.

During the site visit, no borings or excavations were observed; however a fire-hydrant and a plugged water well were observed north of Colton Bluff Springs Road on the western edge of Cottonmouth Creek (**Appendix B, Photograph 12**). No other water wells, borings, or excavations were identified within the site by visual reconnaissance.
